FAYETTE NEW CITY LAKE DAM

MO 10130

**PHASE 1 INSPECTION REPORT
NATIONAL DAM SAFETY PROGRAM**

PREPARED BY: HOSKINS-WESTERN-SONDEREGGER, INC.

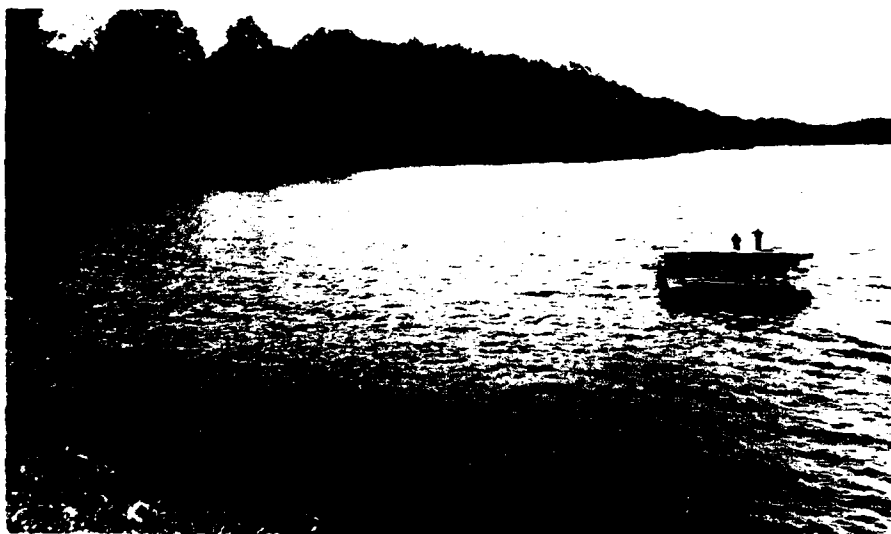
PHOTO NO. 3
INLET STRUCTURE
TAKEN FROM STA. 5+00

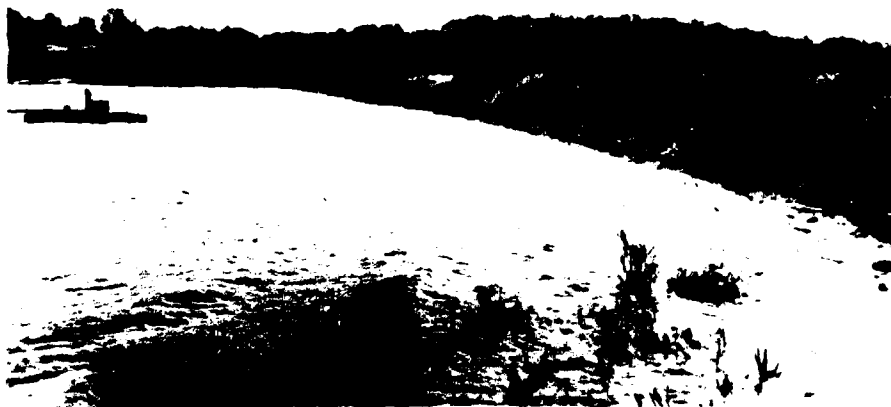
PHOTO NO. 4
INLET STRUCTURE AND
UPSTREAM SLOPE TAKEN
FROM RIGHT ABUTMENT

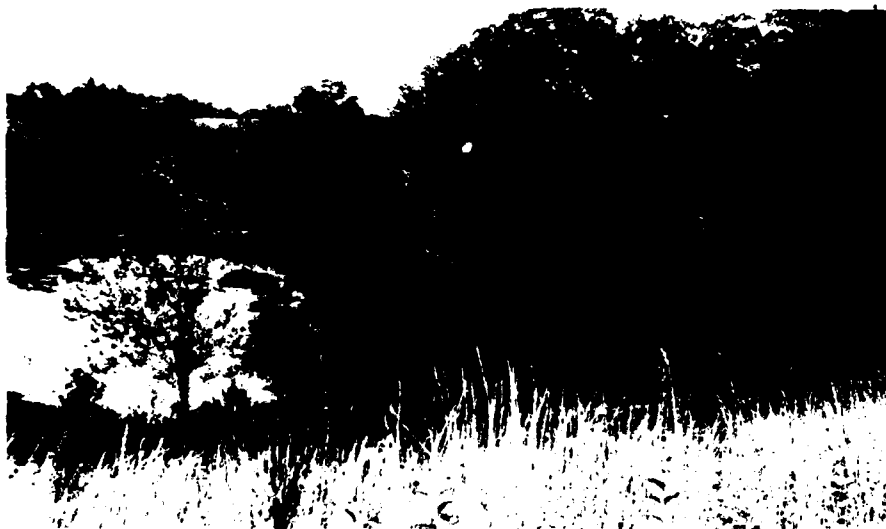
PHOTO NO. 6
RIGHT ABUTMENT
TAKEN FROM STA. 4+70

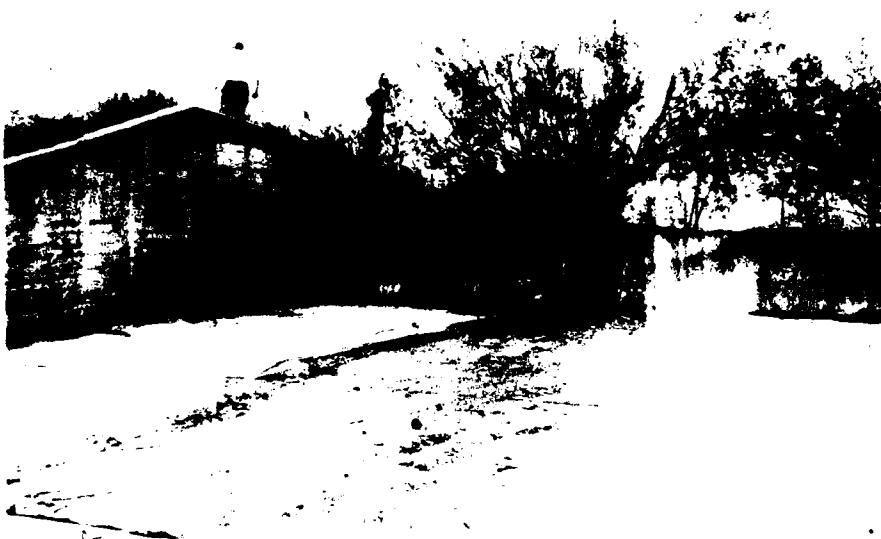
- (1) Spillway. The spillway consists of an ogee weir with a concrete outfall or exit channel, built at the left abutment. Spillway details are shown in Appendix C. The inlet to the spillway is riprapped and was found to be nearly blocked with trees and bushes. No erosion of the inlet was observed. The concrete in the ogee section is deteriorating, and the weir had several horizontal cracks from which water was seeping. A wire fence along the top of the weir could affect the operation of the spillway. The seepage water coming out of the ogee weir flowed along the concrete floor of the channel and disappeared into a joint about 25 feet downstream from the weir (see Photo No. 12).

PHOTO NO. 12
WATER LEAKING FROM
CRACK IN WEIR

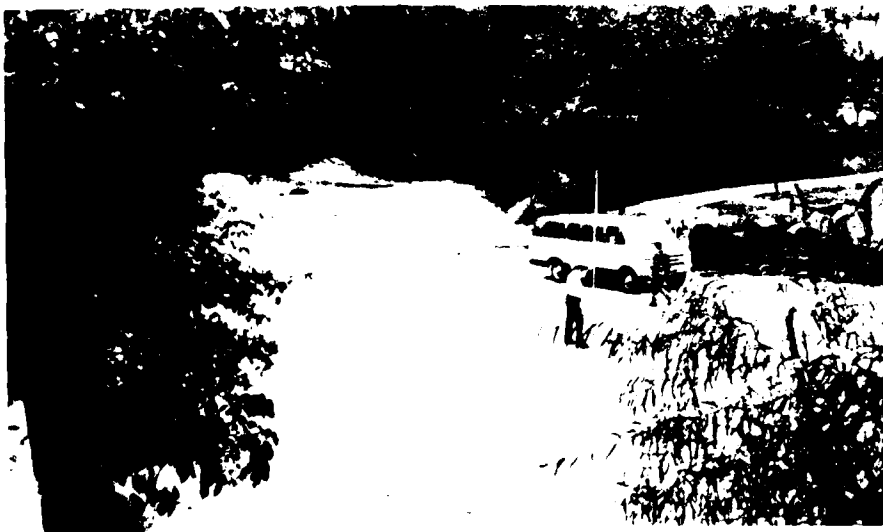
PHOTO NO. 13
DOWNSTREAM FROM
OGEE SPILLWAY
